ECOLOGICAL SCOPING ASSESSMENT

Site Name:	The Hatches	Location (Address):	GU16 6HG
Grid Reference:	SU 88372 56752	Report Date:	13/10/2020

Due to health and safety concerns it has been proposed that a footbridge should be installed to replace the current pedestrian level crossing. In accordance with Network Rail's environmental policy and relevant UK legislation, an ecological assessment was required to determine any ecological constraints to the proposed works.

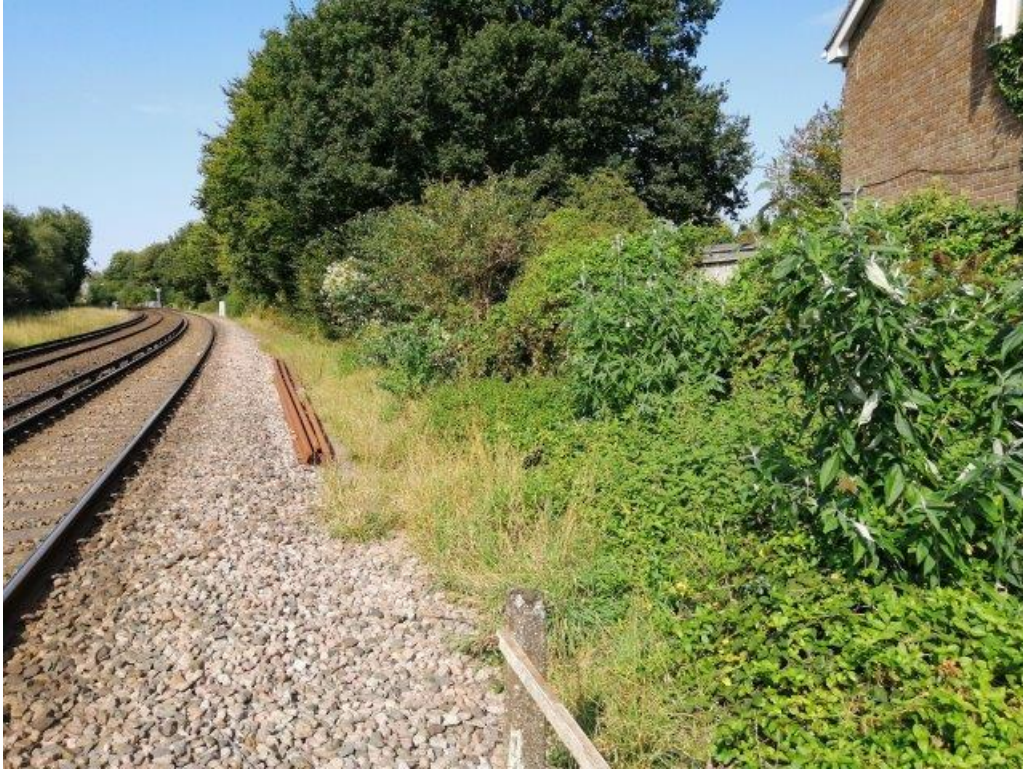
Directly east of the running line, north of the pedestrian crossing adjacent to the cess is a strip of unimproved grassland with a long sward. A strip of shrub and scrub habitat is also present which contains species such as bramble (*Rubus fruticosus*), hazel (*Corylus avellana*), holly (*Ilex aquifolium*), and Russian vine (*Fallopia baldschuanica*). Towards the northern end of the site the shrub/ scrub habitat changes to a treeline of pedunculate oak (*Quercus robur*), and beech (*Fagus sylvatica*).

Image 1. East of the running line, north of the pedestrian crossing facing north.

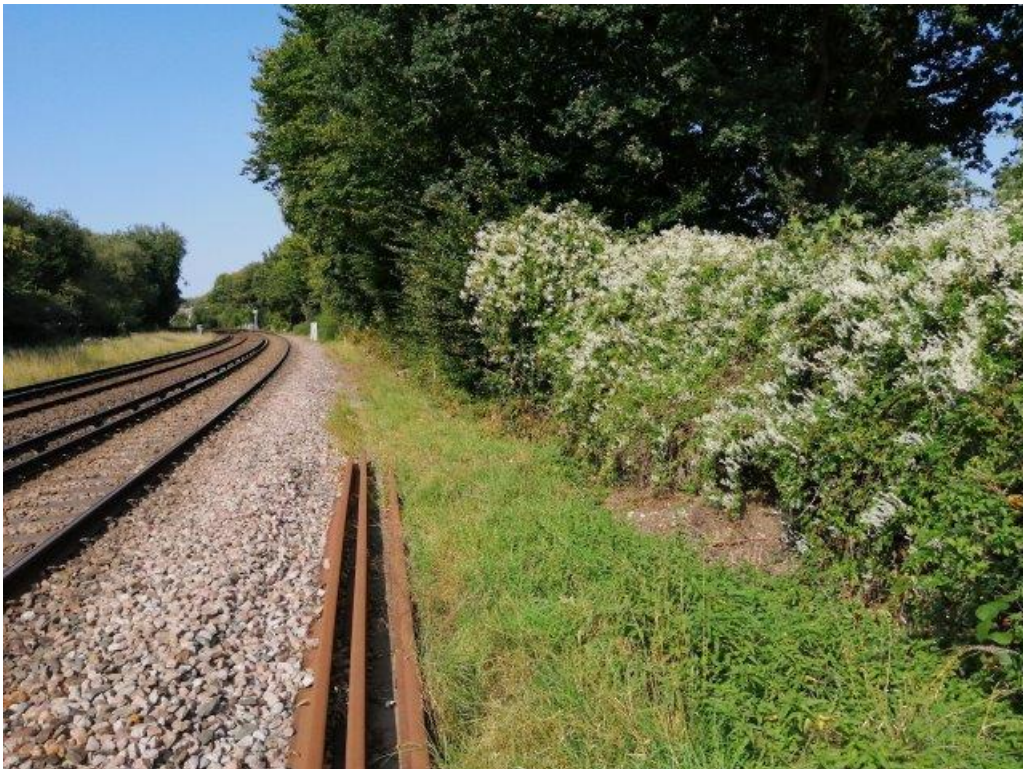
Russian Vine is present on site. Although this species is not listed under Schedule 9 of the Wildlife and Countryside Act 1981 (as amended) it is still a highly invasive species.

Image 2. View of the Russian vine (plant with white flowers).

Russian Vine is present on site. Although this species is not listed under Schedule 9 of the Wildlife and Countryside Act 1981 (as amended) it is still a highly invasive species. Therefore, great care should be taken to prevent the spread of this species to other areas of the site and into the wild.

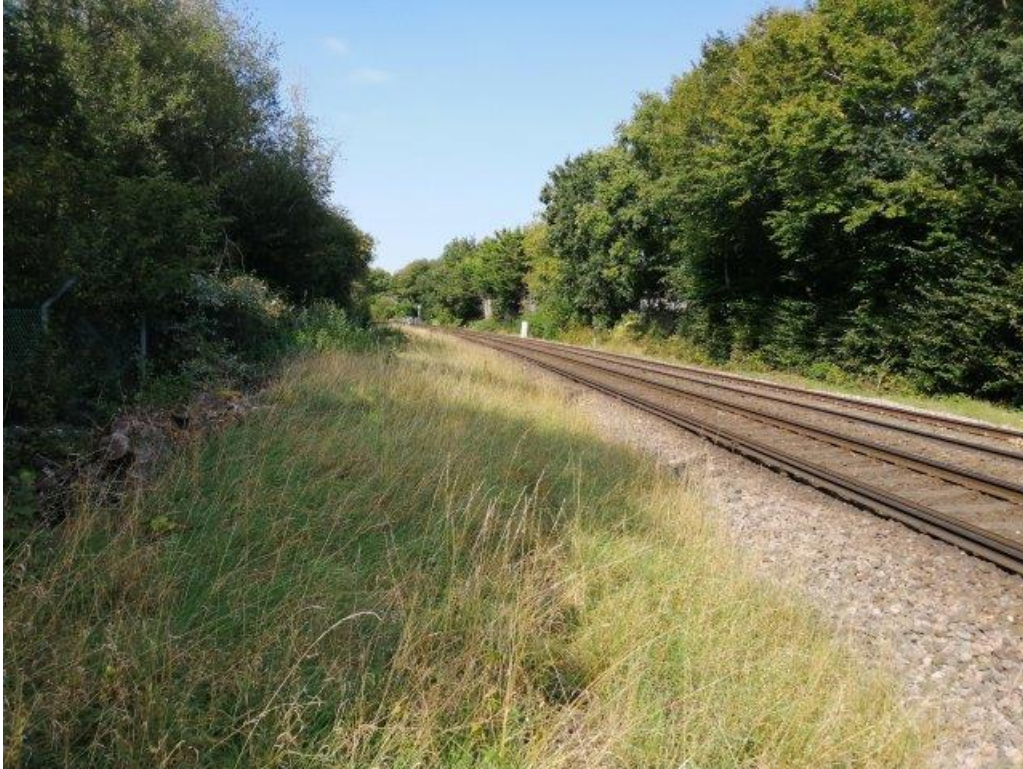
Directly west of the running line, north of the pedestrian crossing adjacent to the cess is a strip of unimproved grassland with a long sward which contains several log piles and patches of bramble (*R. fruticosus*). Adjacent to the unimproved grassland is strip of woodland. Species here include scots pine (*Pinus sylvestris*), ash (*Fraxinus excelsior*), and pedunculate oak (*Q. robur*).

Image 3. Area of unimproved grassland with long sward – west of the running line, north of the pedestrian crossing.

As the works will impact suitable reptile habitat, reptile surveys should be carried out to establish whether reptiles are present. This is in line with Natural England's standing advice: (<https://www.gov.uk/reptiles-protection-surveys-and-licences>). Standard methods involving a SQE placing sheets of heavy-duty roofing felt (artificial refugia) in areas where they are most likely to be used by reptiles (e.g. at the edges of bramble scrub, in the unimproved grassland with long sward, next to the log piles). So far as possible, the artificial refugia should be placed on slightly uneven ground so as not to lie completely flat (to create a varied microclimate).

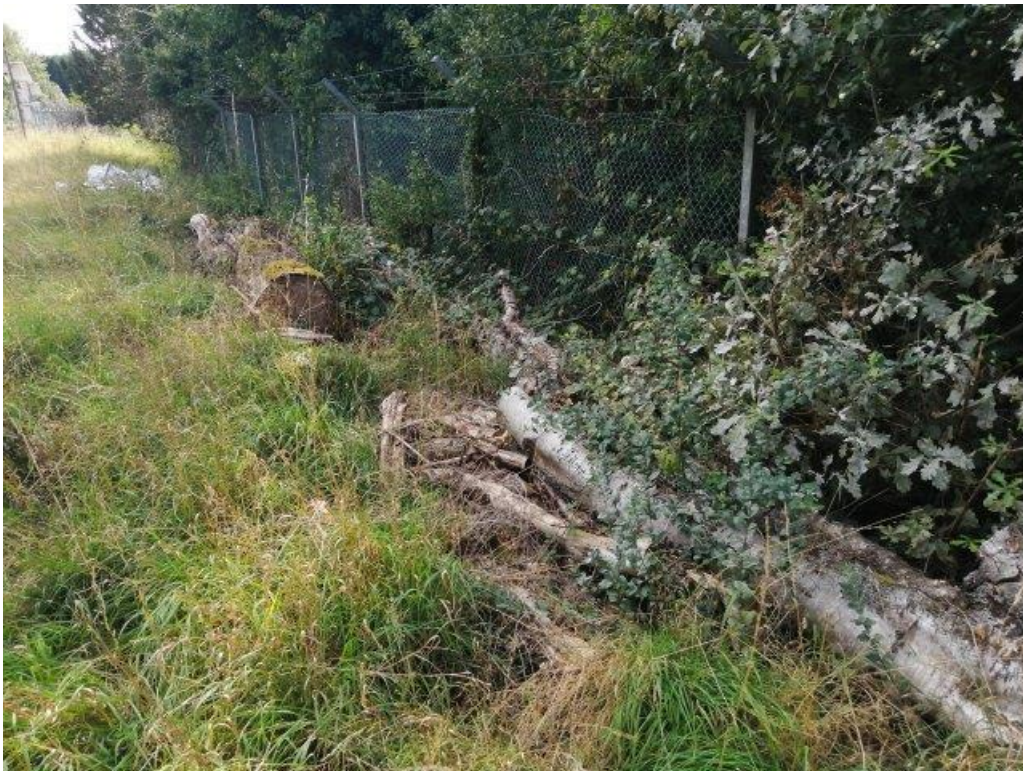
The site is considered to be of high suitability for reptiles. The unimproved grassland and patches of bramble scrub provide good foraging habitat. In addition, there are several log piles on site that provide suitable hibernation habitat. Furthermore, the data search conducted by SBIC found records of adder (*Vipera berus*), grass snake (*Natrix natrix*), slow-worm (*Anguis fragilis*), and common lizard (*Zootoca vivipara*) within 1 km of the site.

Image 4. Several log piles – west of the running line, north of the pedestrian crossing.

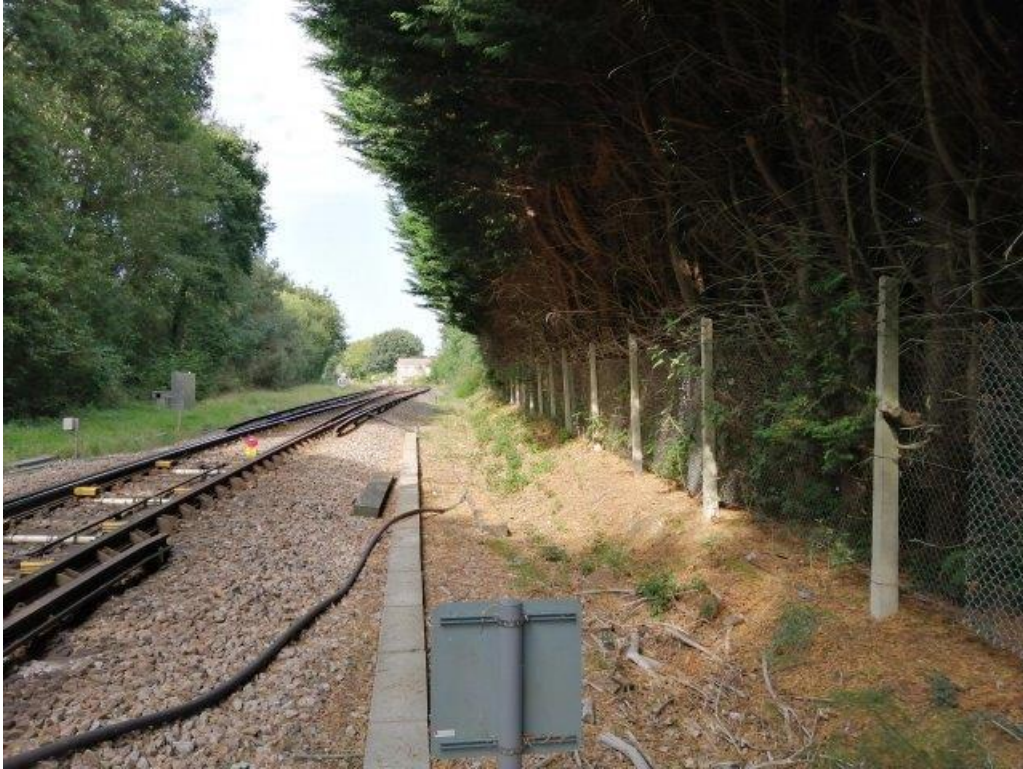
Image5. Stood at the southern end of the site facing north.

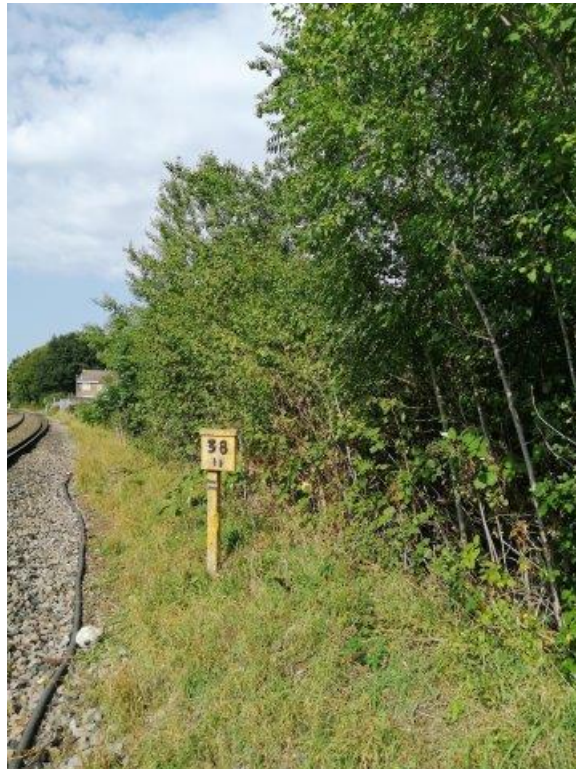
Image 6. Stood approximately 70 m south of the pedestrian crossing facing north.

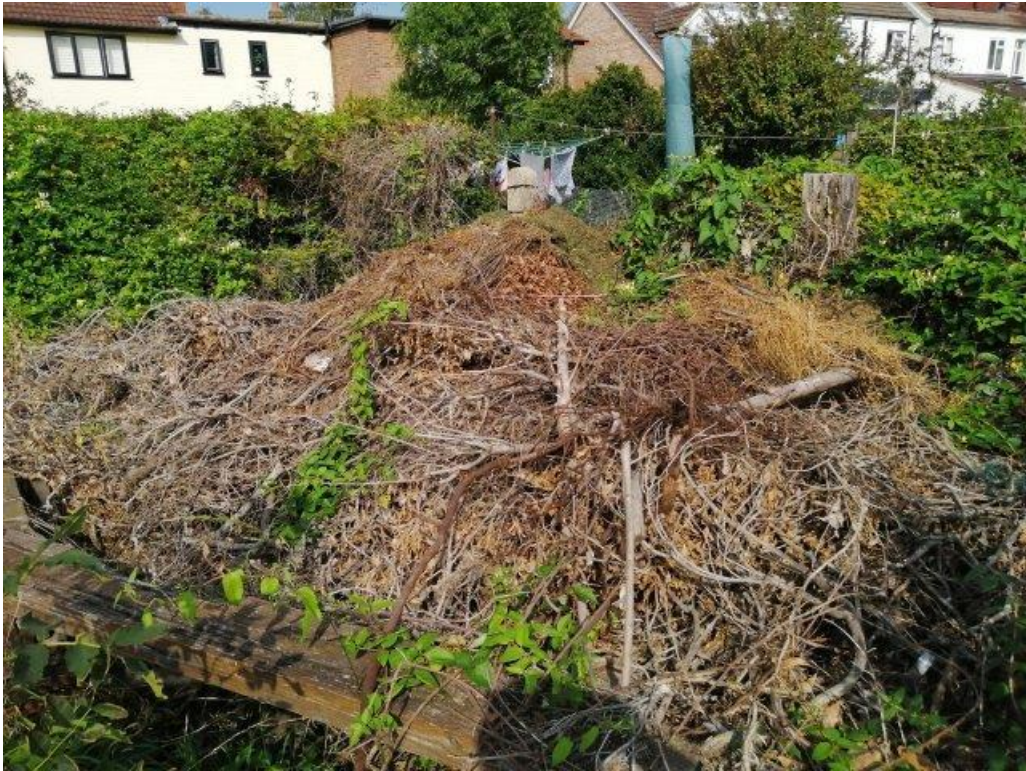
Directly west of the running line, south of the pedestrian crossing is an area of shrub/ scrub habitat measuring approximately 60 m in length. Species here include ash (*F. excelsior*), sycamore (*Acer pseudoplatanus*), hazel (*C. avellana*), hawthorn (*Crataegus monogyna*), young pedunculate oak (*Q. robur*), a species of honeysuckle (*Lonicera*), bramble (*R. fruticosus*), a species of rose (*Rosa*), and common nettle (*Urtica dioica*). A large pile of

garden waste is also present here. South of this habitat the vegetation adjacent to the cess ends and is replaced by bare ground with a strip of coniferous trees to the east. In the wider landscape the village of Frimley Green extends to the north and east; fishing lakes are present to the west; and the village of Mytchett is to the south. There are several large blocks of woodland approximately 1 km east, 1 km south-east, and 3.4 km north-west of the site.

Image 7. Pile of garden waste south of the pedestrian crossing.
